Manhole Inspection Summary

Manhole # S1900_019MH

Insp Date: **7/5/07 9:58 AM**

Location Address: **2001 BRYANT AVE**

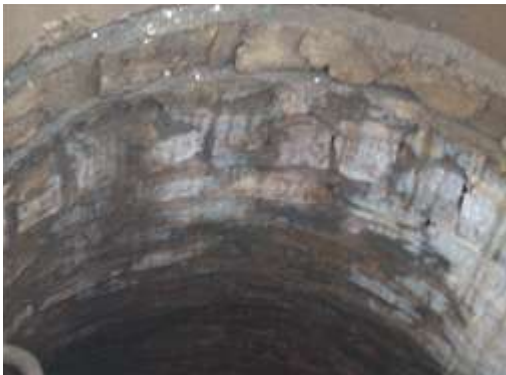
Defect 4

Infiltration: ☐ None ☐ Joint ☐ Cracks ☐ Mortar ☐ Roots ☒ Wall

INFILTRATION OF CORBEL WALL

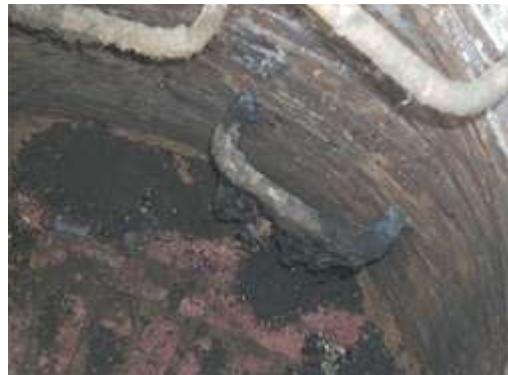
Defect 3

Surcharge ☒ Evidence Of Surcharge Depth: **2** (ft.) ☐ Active Surcharge Present

EVIDENCE OF SURCHARGE ON STEPS

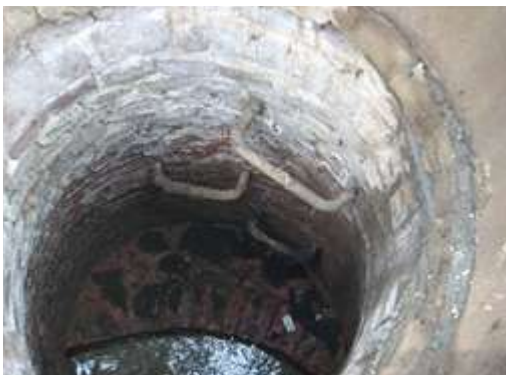
Defect 2

Steps Count: **3** Missing: **0** ☒ Corroded

CORRODED STEPS

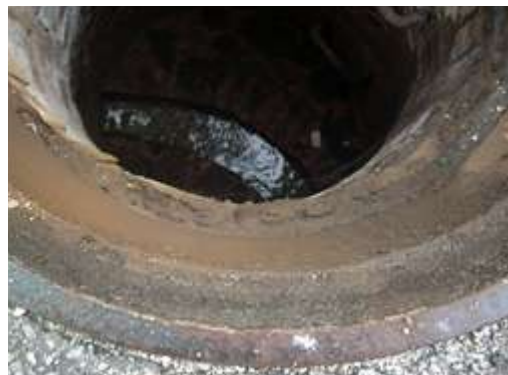
Defect 1

Frame Offset: **1** (in.) Condition: ☒ Sound ☐ Cracked ☐ Leaks

FRAME OFFSET

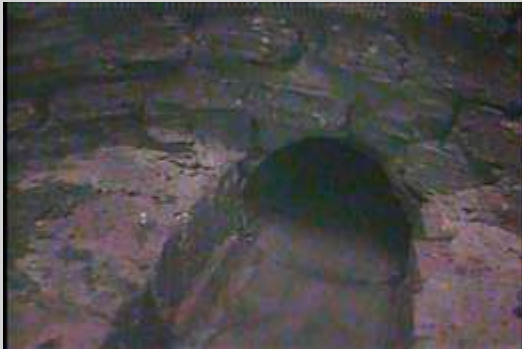
12 O'Clock Outflow

8 in. Circular Gravity Sewer
Pipe Out @ 12 O'Clock

Pipe Height: **8.4** (in.) Rod and Bar (Angled)
Pipe Material: **Clay** ☐ Pipe Lined
Invert Depth: **7.84** (ft.) Flow Characteristics: **Slow**
Deposits: ☒ None ☐ Mud ☐ Sludge ☐ Debris ☐ Grease
Silt Depth: (in.) Deposits Extent:
Infiltration: **None** Pipe Seal Cond: **Sound**

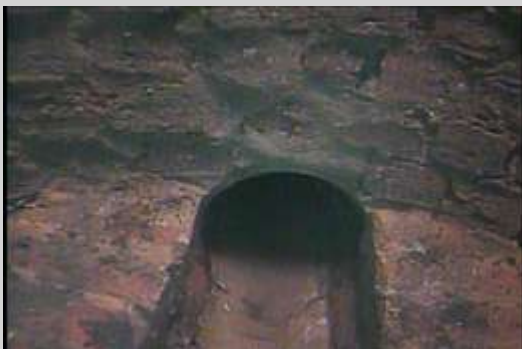
8 O'Clock Inflow

8 in. Circular Gravity Sewer
Pipe In @ 8 O'Clock

Pipe Height: **8.4** (in.) Rod and Bar (Angled)
Pipe Material: **Clay** ☐ Pipe Lined
Invert Depth: **7.81** (ft.) Flow Characteristics: **Slow**
Deposits: ☒ None ☐ Mud ☐ Sludge ☐ Debris ☐ Grease
Silt Depth: (in.) Deposits Extent:
Infiltration: **None** Pipe Seal Cond: **Sound**
